2012 Annual Inspection and Maintenance Report for North Maybe Mine - East Mill Creek Restored Sediment Control Structure

Submitted by:
Nu-West Industries, Inc. and Nu-West Mining, Inc.

Submitted to:
United States Department of Agriculture, Forest Service

December 2012

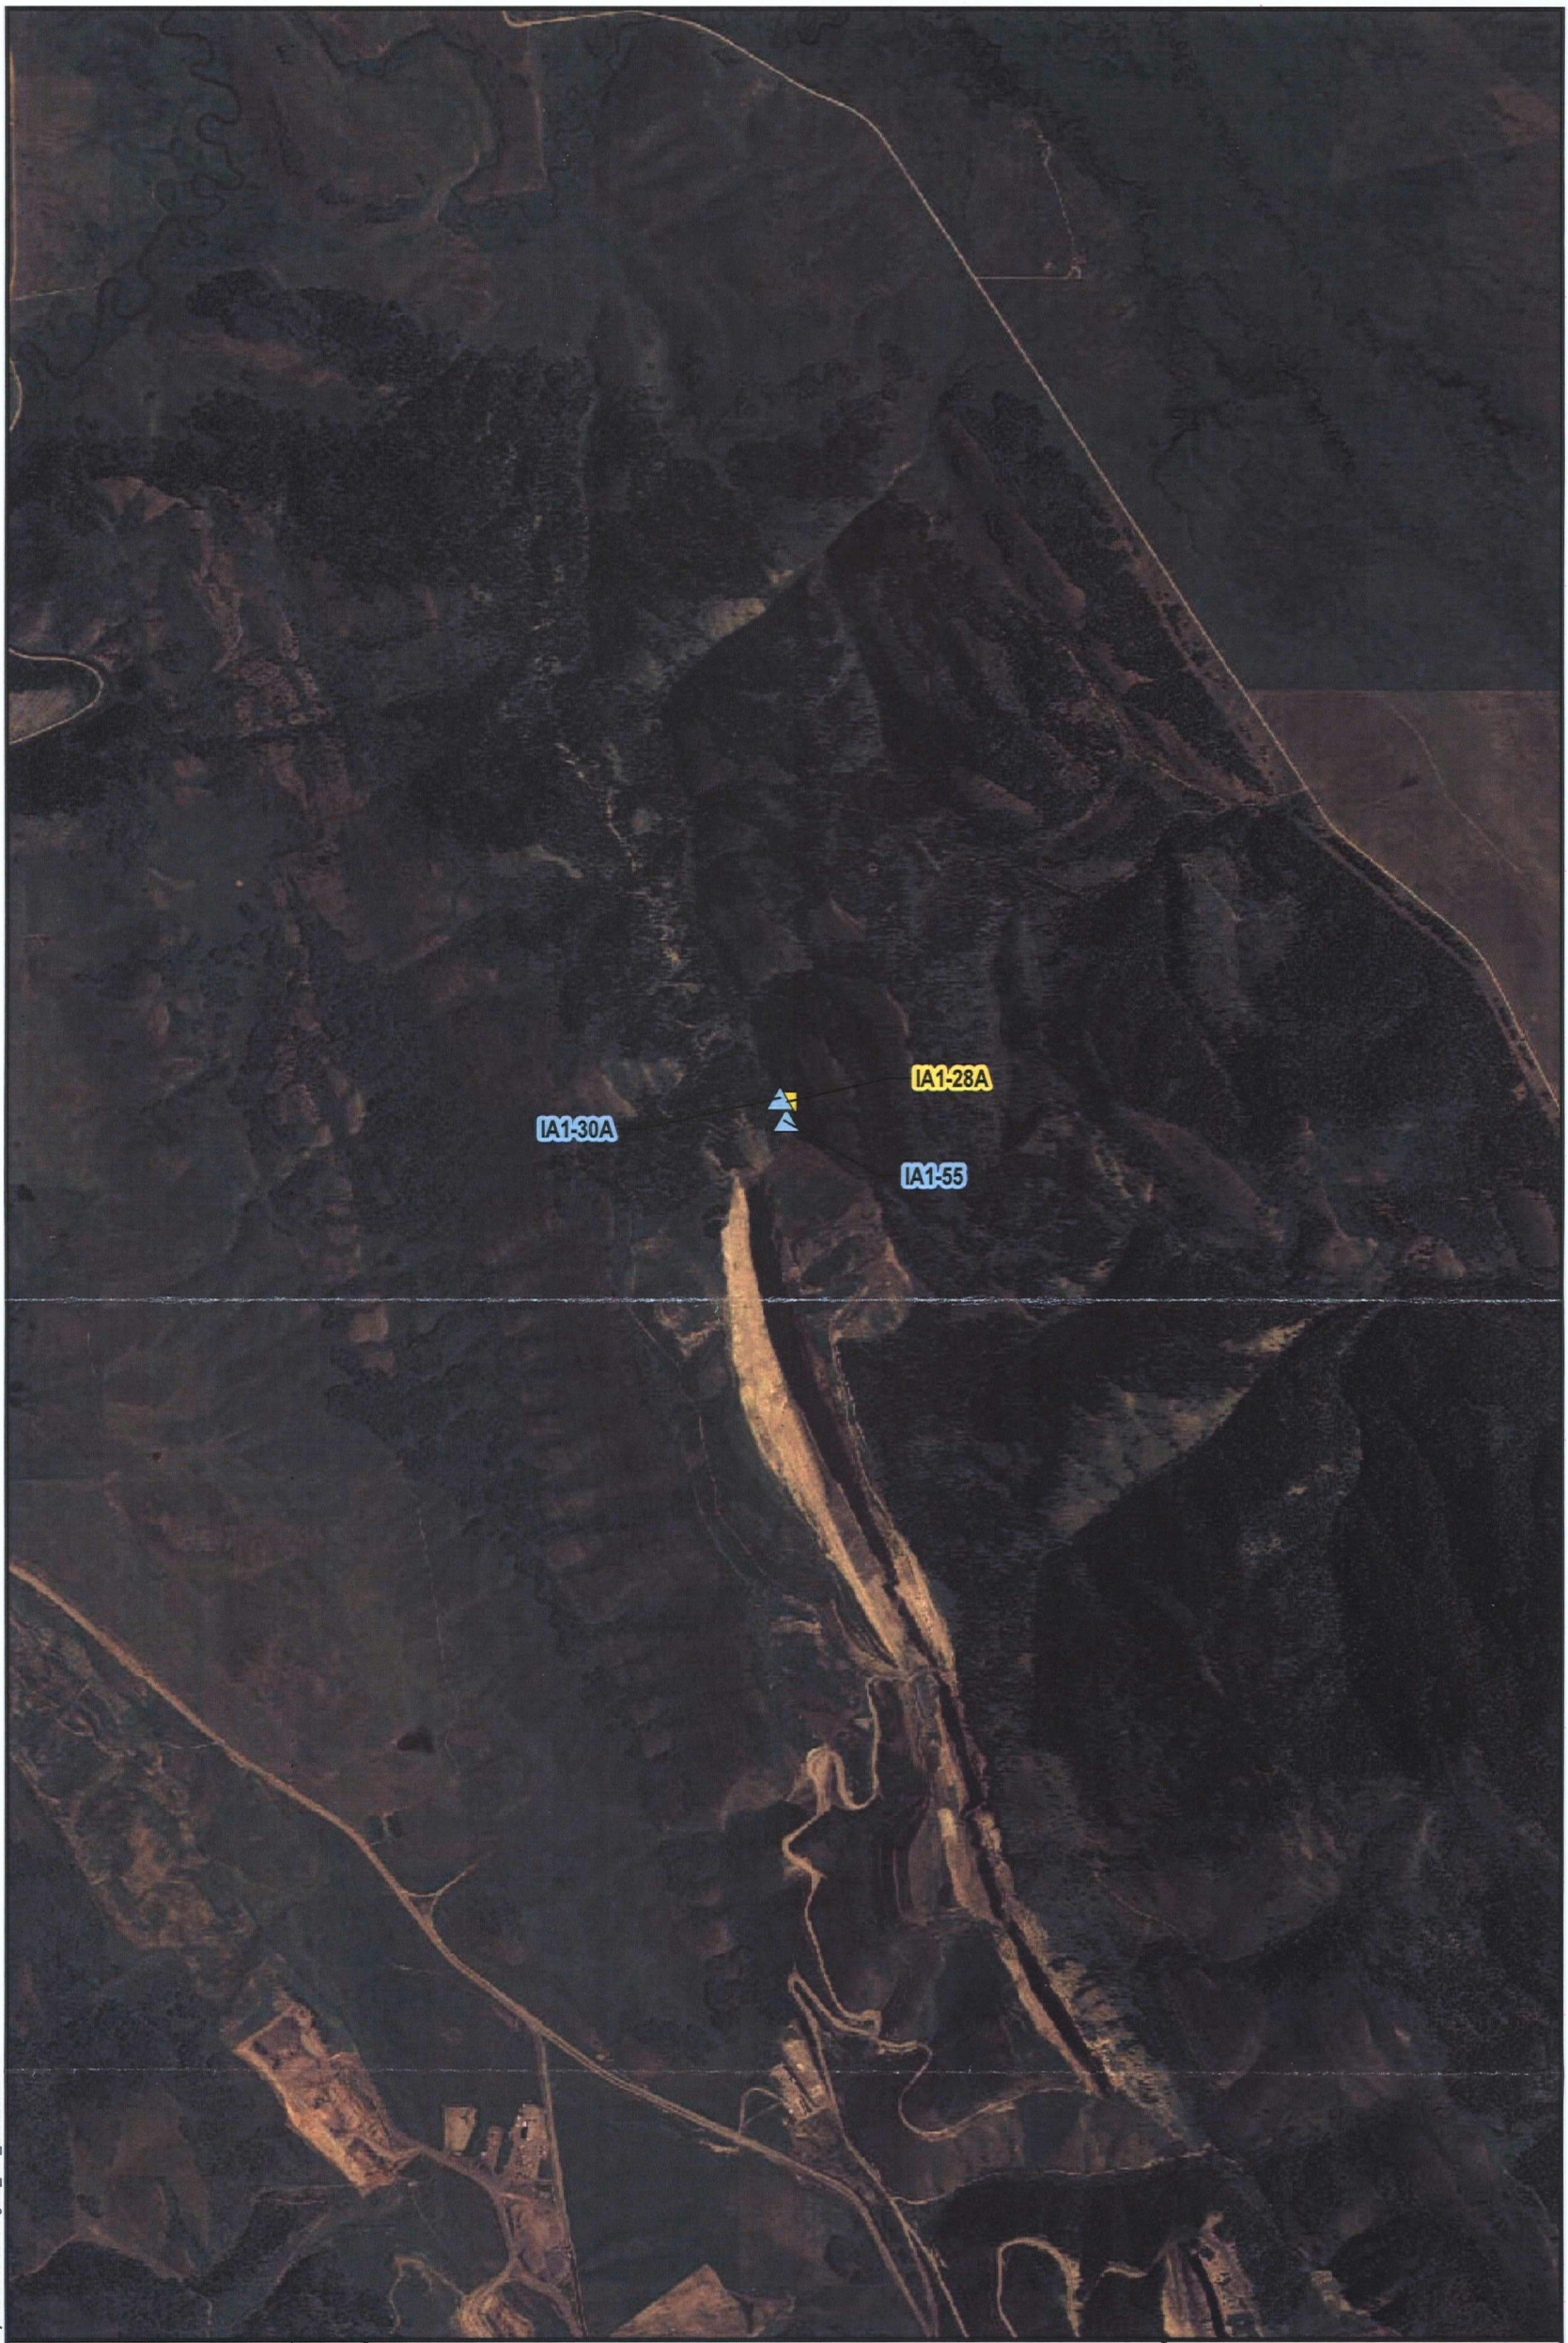
Figure 2-2
Plan and Profile from As-Built Survey

Each of these site features are identified on either Figure 2-1 or 2-2. Features that immediately surround the sediment control structure are presented on Figure 2-2 while features that are further away (e.g., soil consolidation area, growth media borrow area) are shown in Figure 2-1.

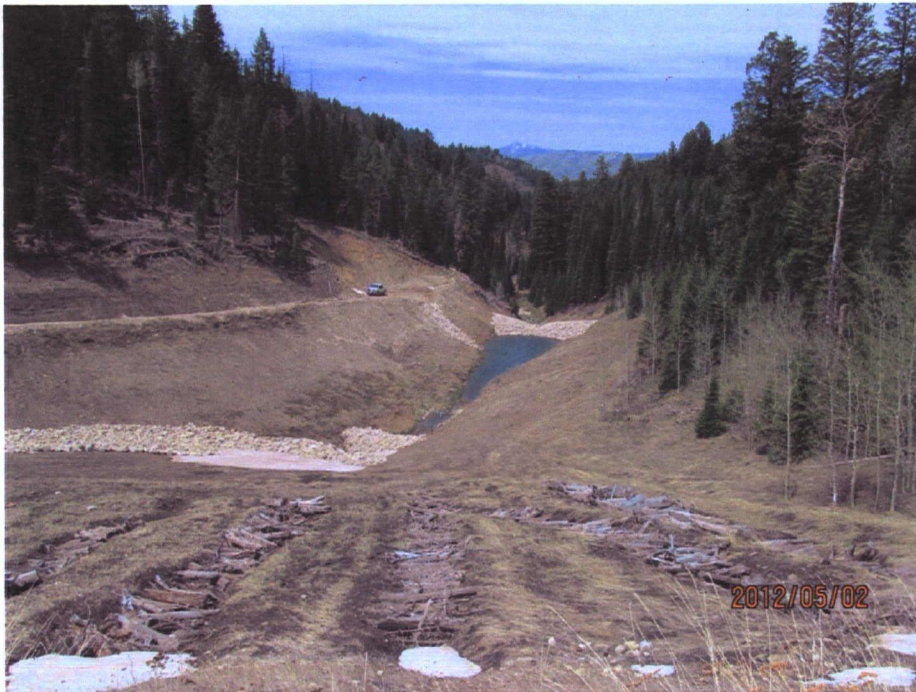
Photo taken looking north, showing the graded area surrounding the sediment pond, riprap below culvert outfalls, riprap energy dissipater, riprap toe berm, logs placed in rills on East Mill Dump and the sediment control structure.

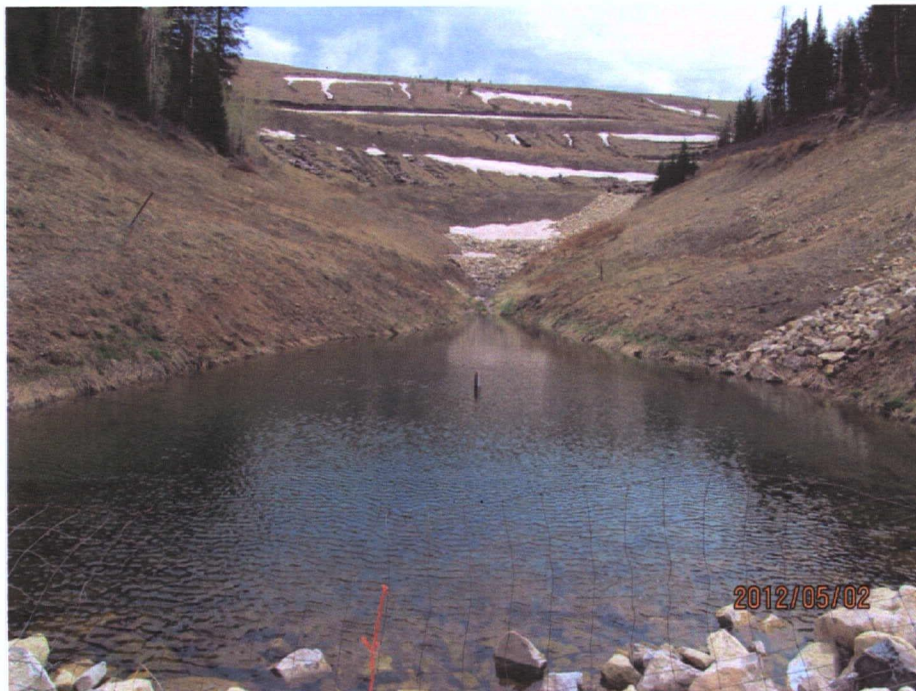
Photo taken looking south, showing that some portions of the graded area surrounding the sediment pond, the riprap energy dissipater and the riprap toe berm are partially covered with snow.

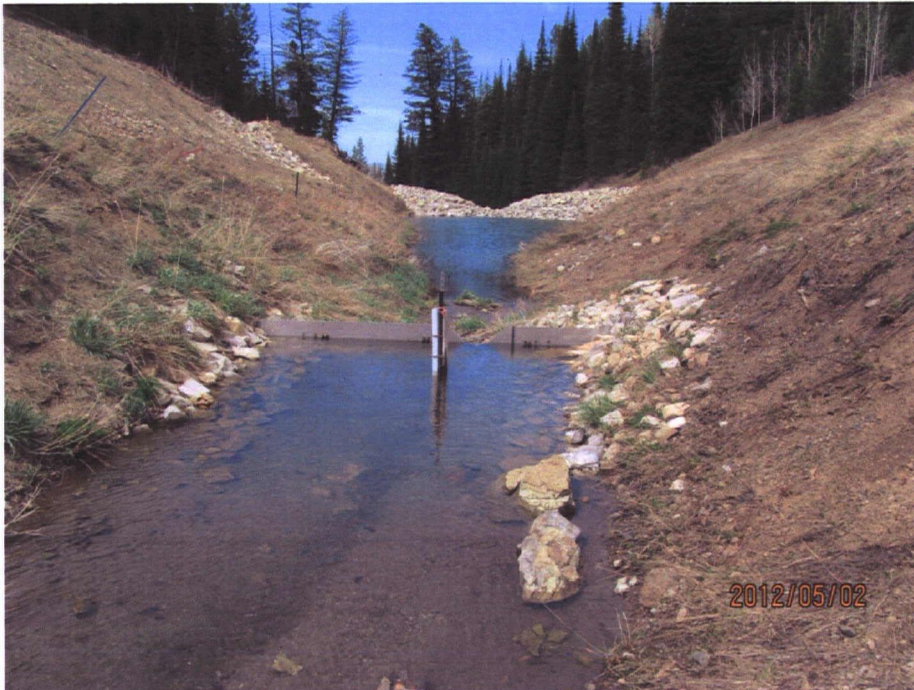
Photo taken looking north, showing the upper V-notch weir, and the sediment control structure.

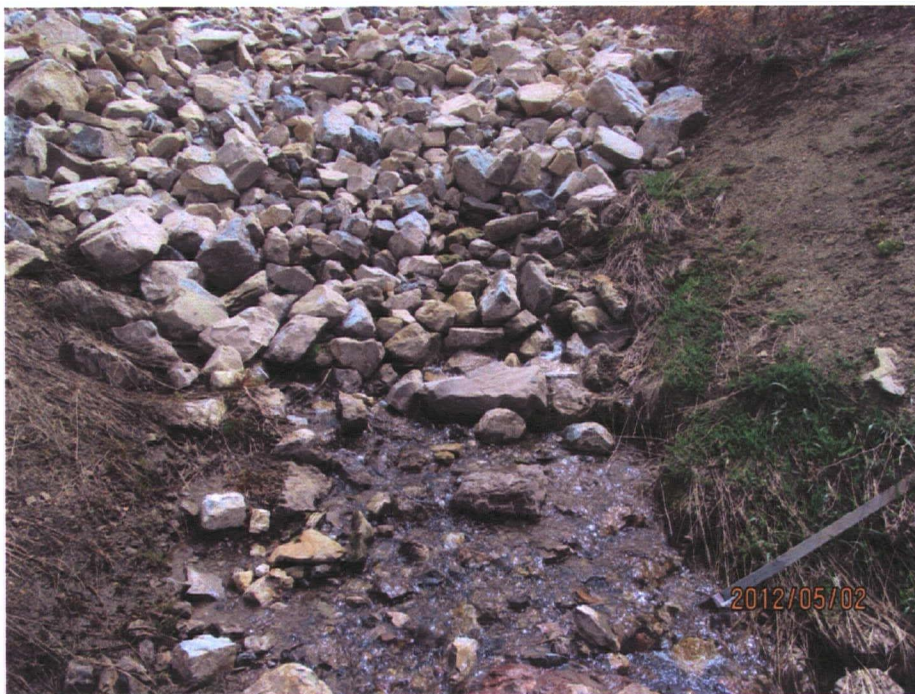
This photo shows the toe of the riprap energy dissipater looking south. This photo shows the riprap energy dissipater is in good condition.

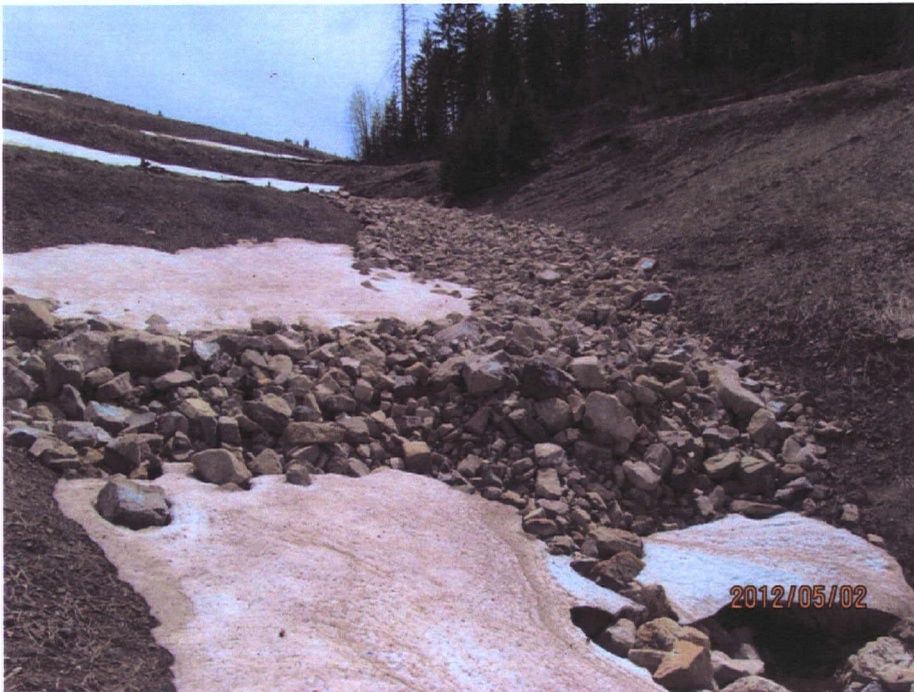
Photo taken looking southwest, showing the riprap toe berm and riprap below the upper culvert. Some snow remaining.

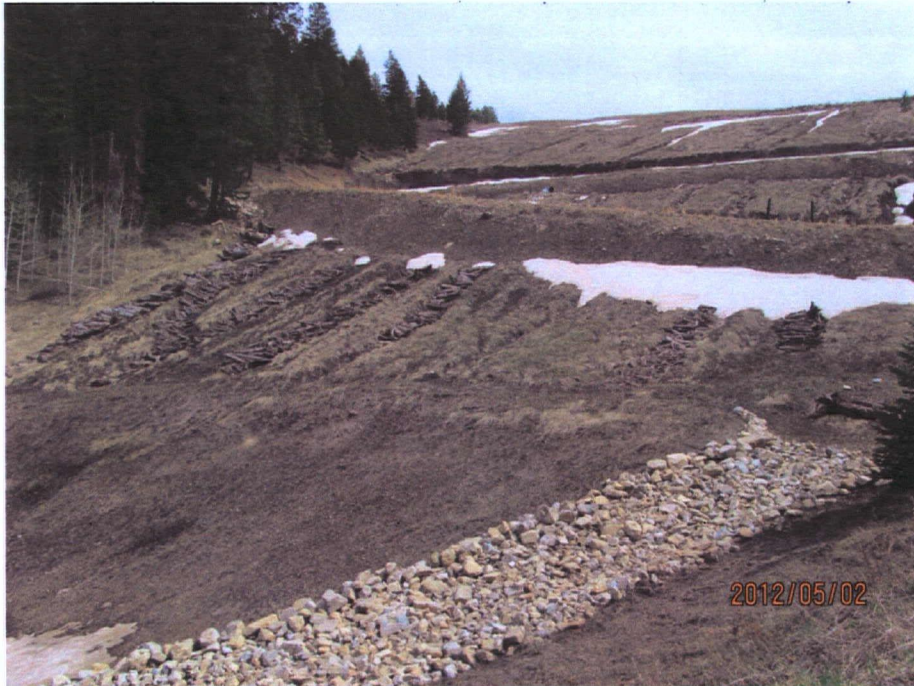
Photo taken looking southeast, showing the riprap below the upper culvert and logs in rills on East Mill Dump. Logs in rills are slightly snow covered.

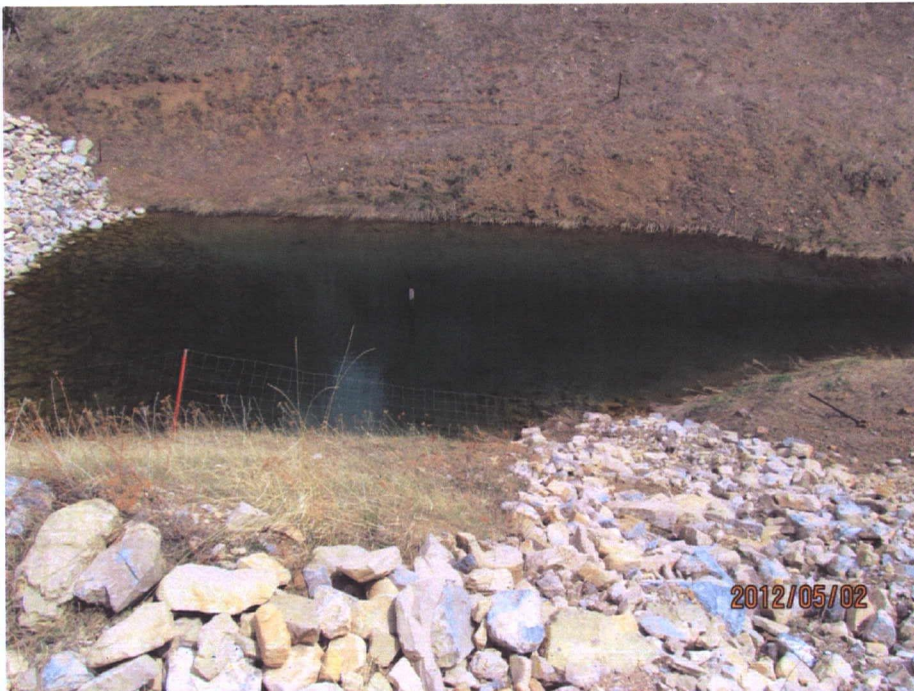
Photo taken looking east, showing the lower culvert riprap outfall (right foreground) and the clarity of the sediment control pond.

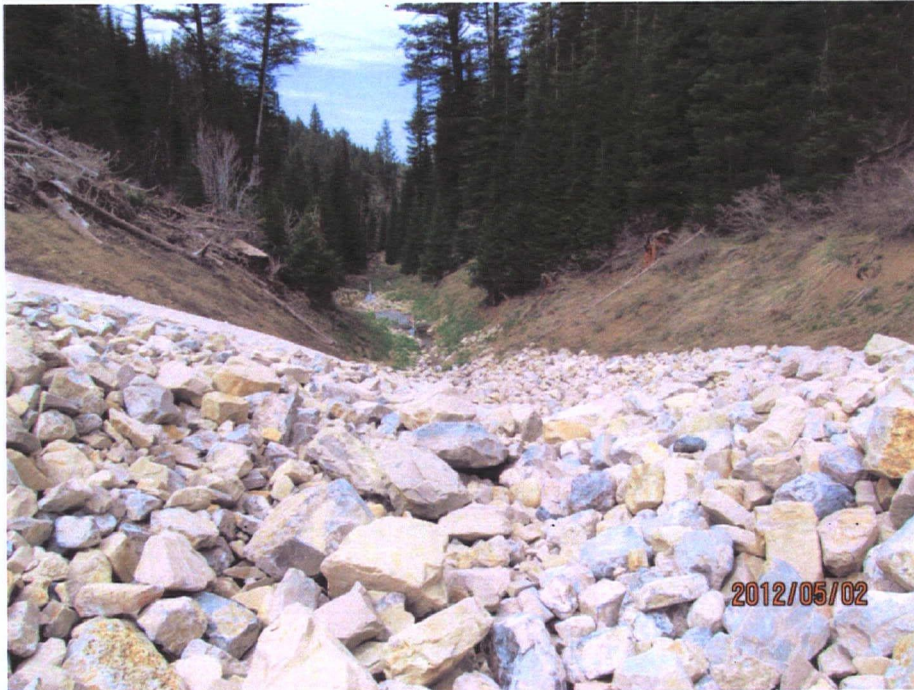
Photo taken looking north, from the top of the sediment control structure showing the lower weir and riprap lined channel below the sediment control structure.

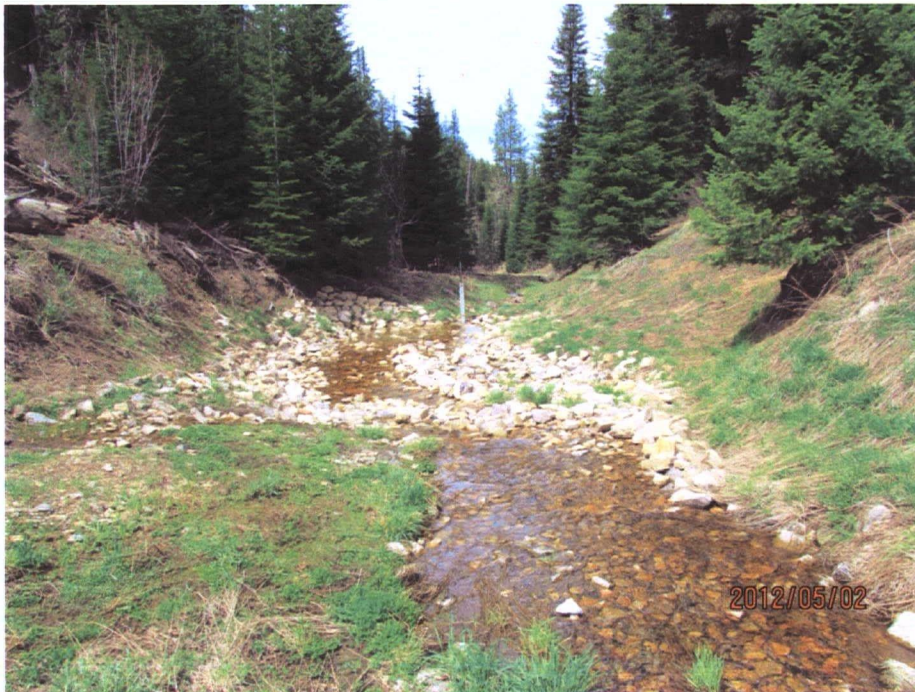
Photo taken looking north, showing a close up of the riprap lined channel below the sediment control structure. This area is stable and in good condition.

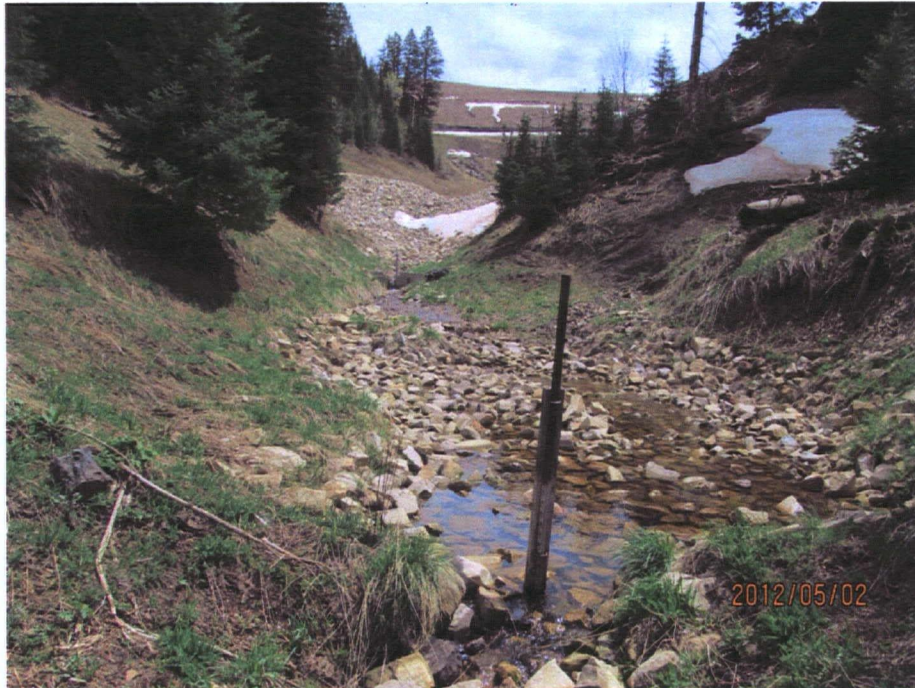
Photo taken looking south, showing the riprap lined channel below the sediment control structure and the lower weir. The riprap channel is in good condition.

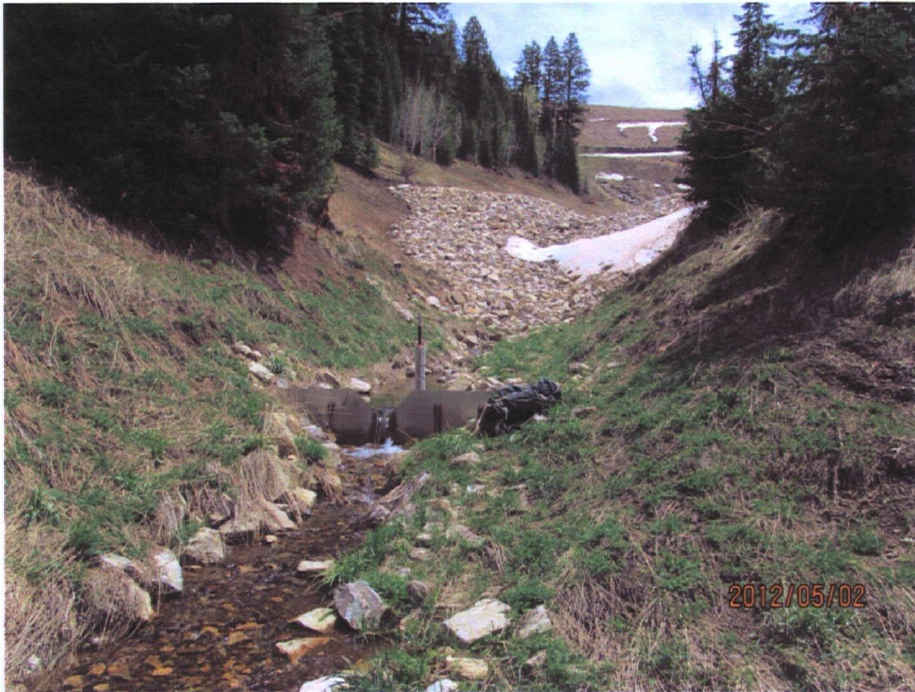
Photo taken looking south of the lower weir and sediment control structure. This area is stable and in good condition.

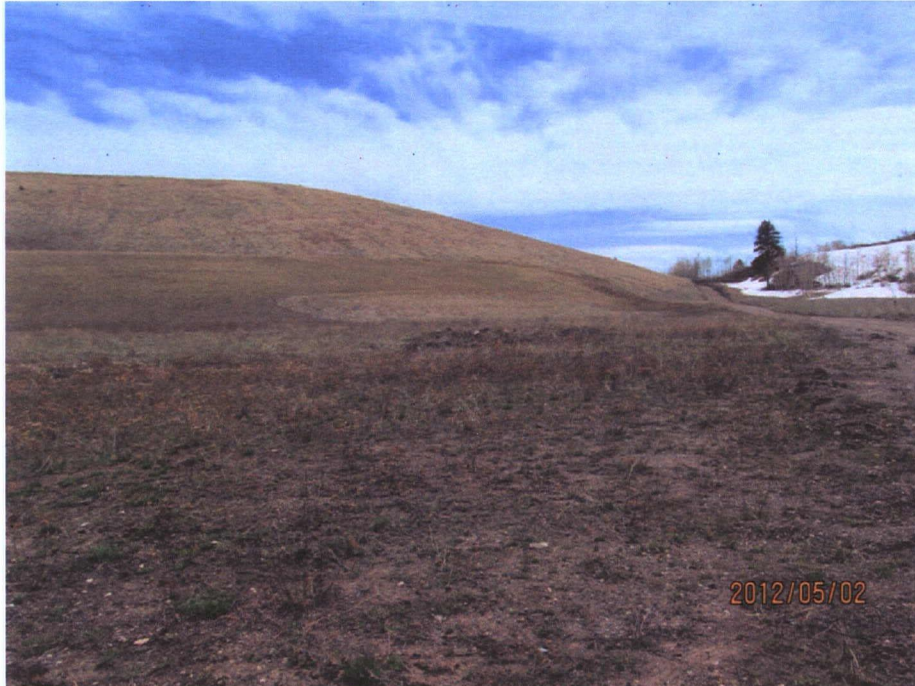
Photo taken looking south, showing the waste consolidation area. Area is free of snow with no evidence of erosion.

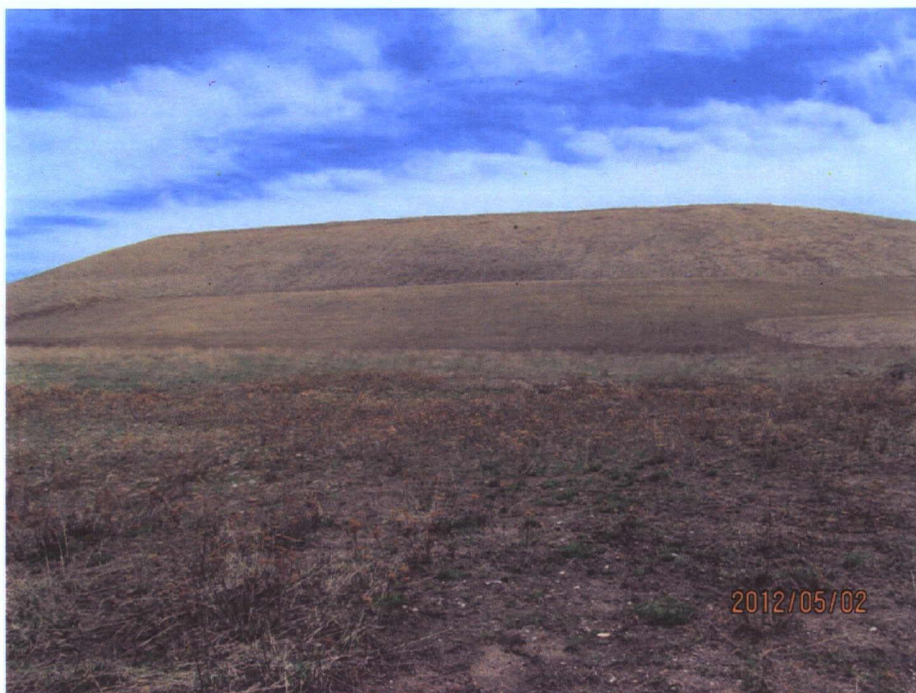
Photo taken looking southeast, showing the waste consolidation area. Area is free of snow with no evidence of erosion.

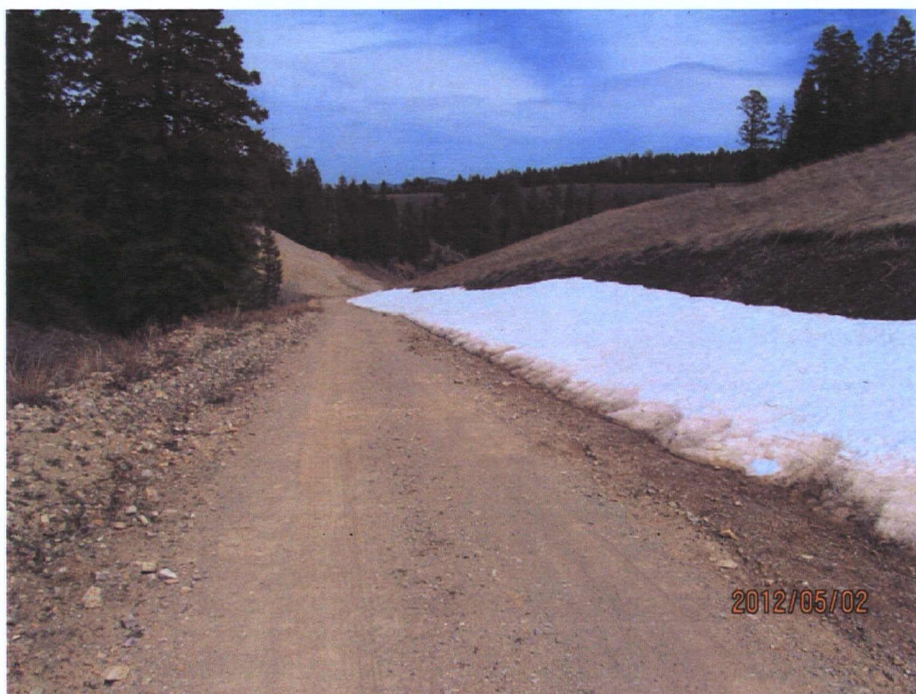
Photo taken looking east, showing the upper access road. Road and ditch are still partially snow covered.

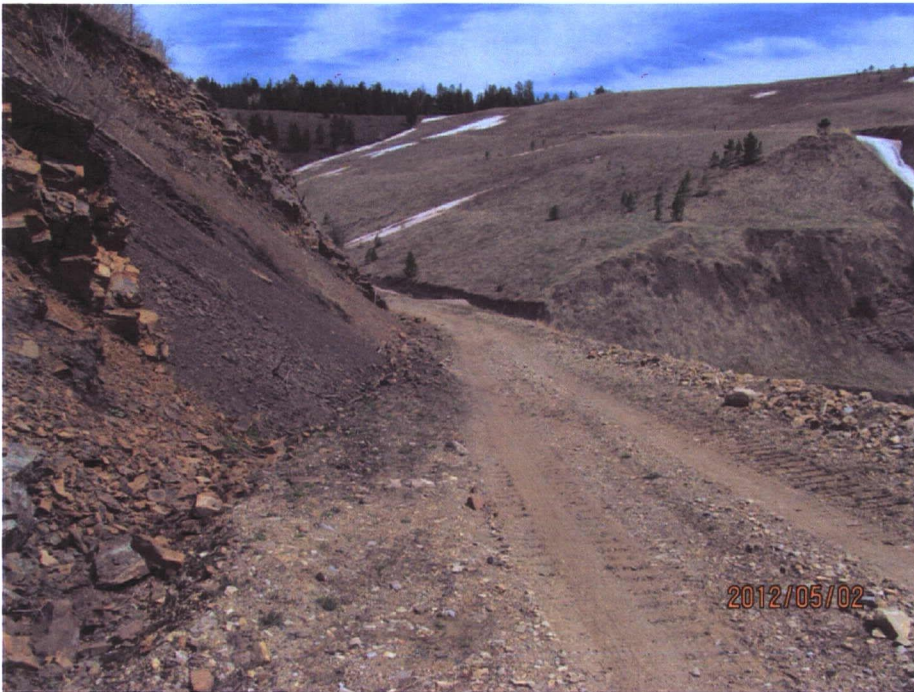
Photo taken looking east, showing the access road along the North Maybe Pit end wall. Some rock has rolled into the ditch but still maintains a flow line.

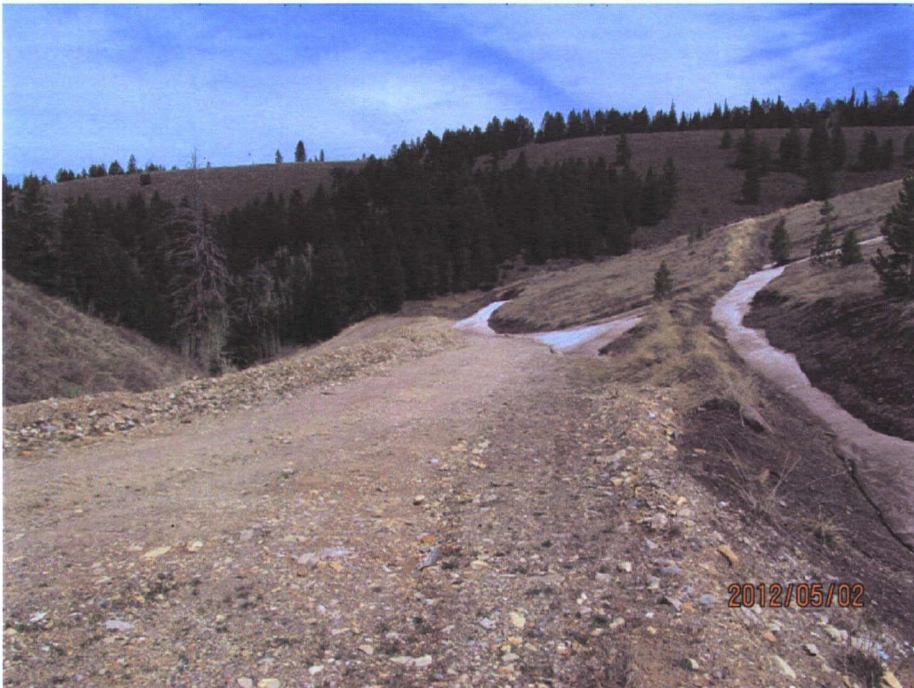
Photo taken looking east, showing the lower portion of the access road. Ditch is still partially snow covered.

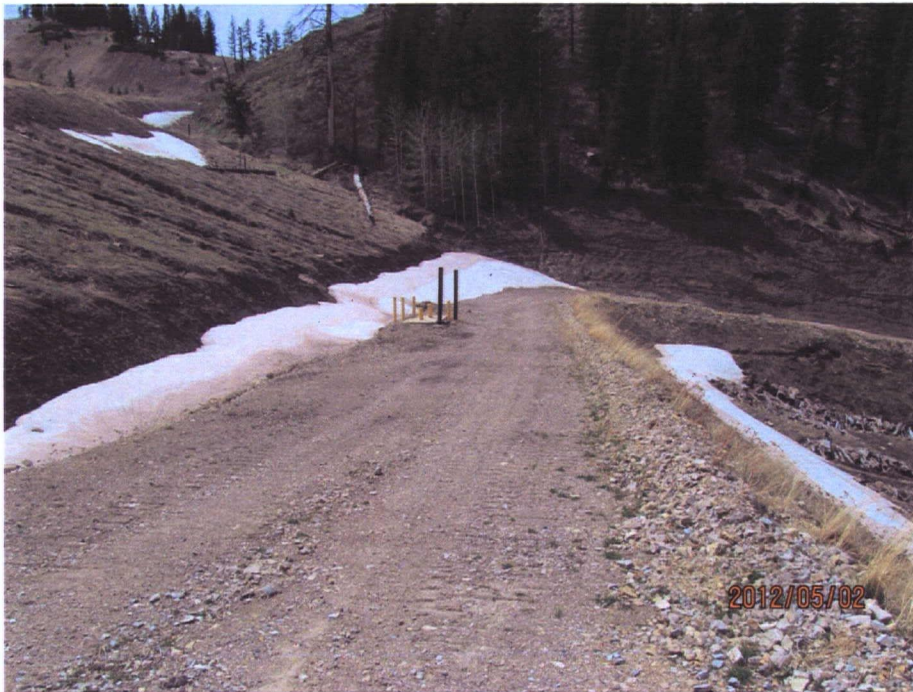
Photo taken looking west, showing the lower portion of the access road. Ditch is still partially snow covered.

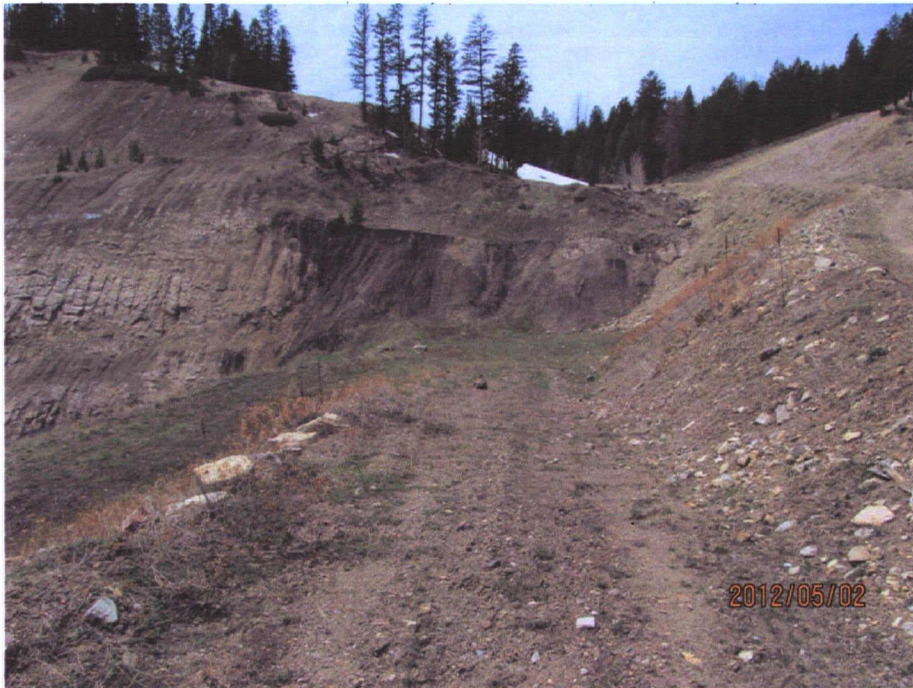
Photo taken looking west, showing the growth media borrow area located at the north end of the pit. This area is holding up well showing no signs of erosion.

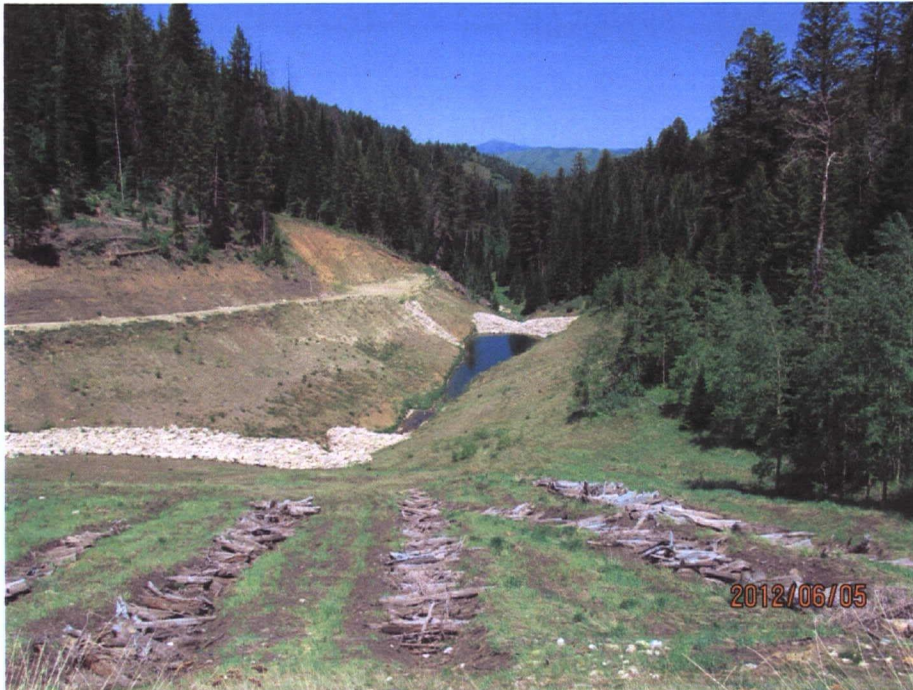
Photo taken looking north, showing the graded area surrounding the sediment pond, riprap below culvert outfalls, riprap energy dissipater, riprap toe berm, logs placed in rills on East Mill Dump and the sediment control structure.

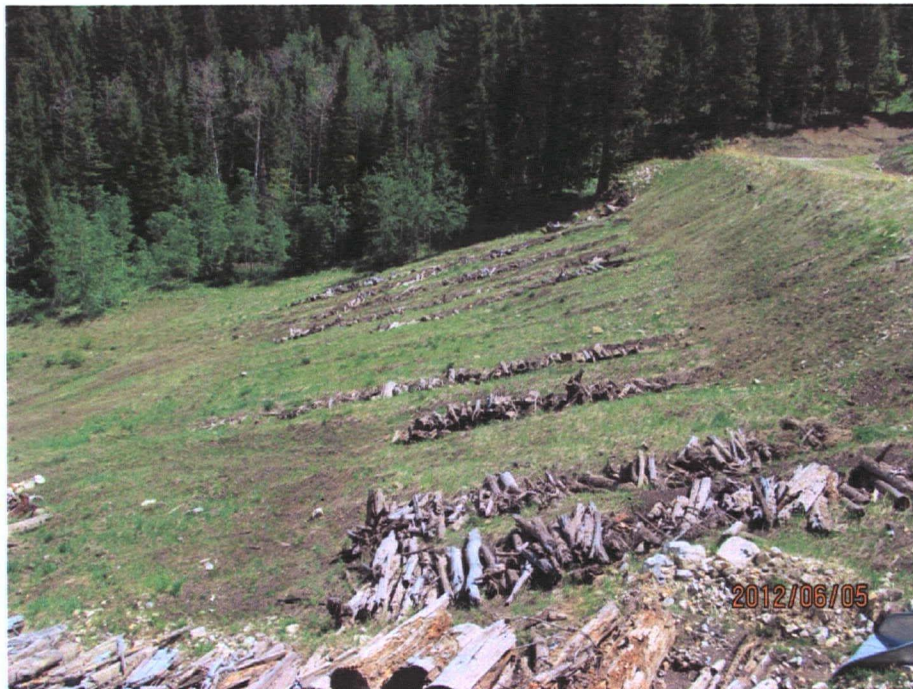
Photo taken looking east showing the logs in the rills on East Mill Dump. No evidence of erosion is present.

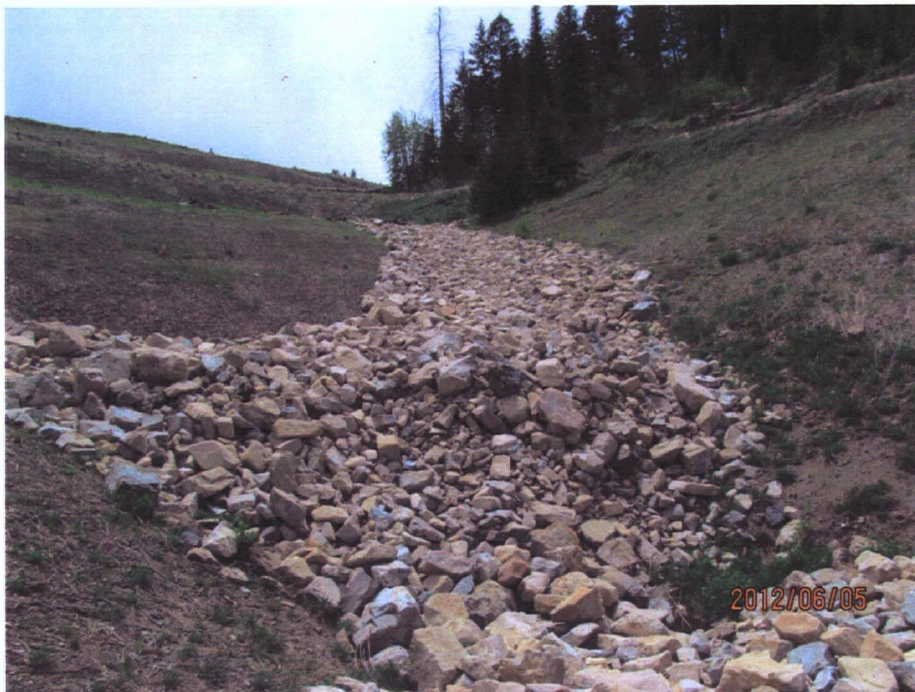
Photo taken looking south, showing the riprap lined upper culvert outfall, the riprap toe berm, and the riprap energy dissipater. No evidence of erosion is present.

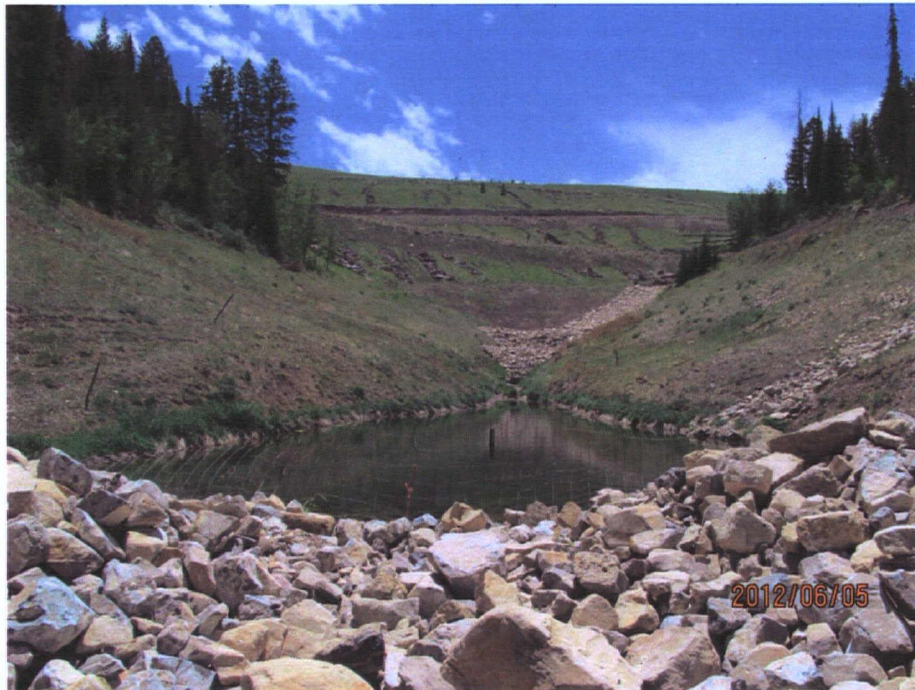
Photo taken looking south, showing the graded area surrounding the sediment pond, riprap below culvert outfalls, riprap energy dissipater, riprap toe berm, logs placed in rills on East Mill Dump and the sediment control structure.

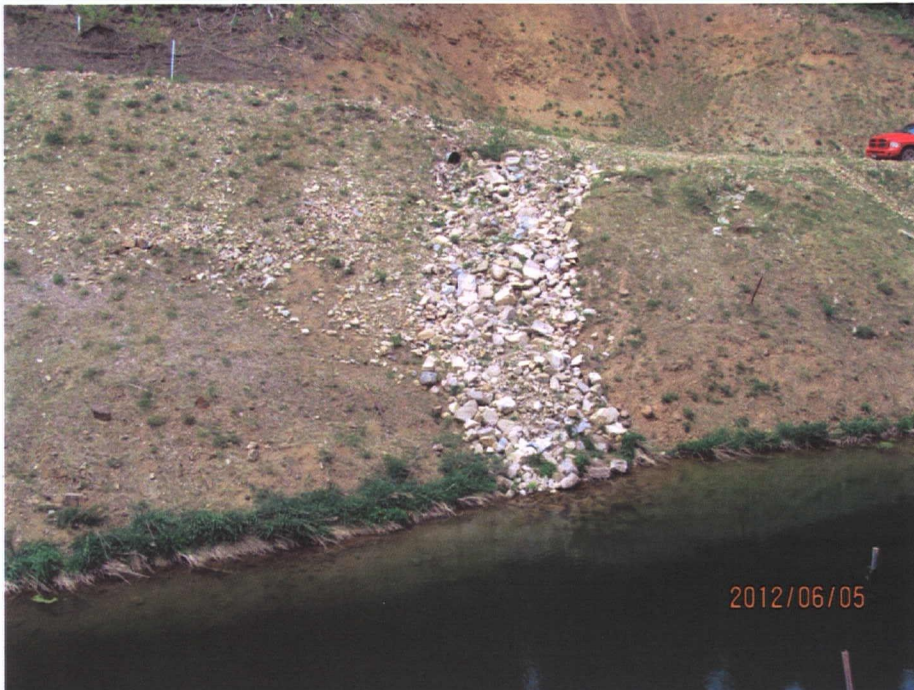
Photo taken looking west, showing the lower culvert outfall and clarity of the sediment control pond. Riprap armor below lower culvert outfall is doing a good job preventing scour and erosion.

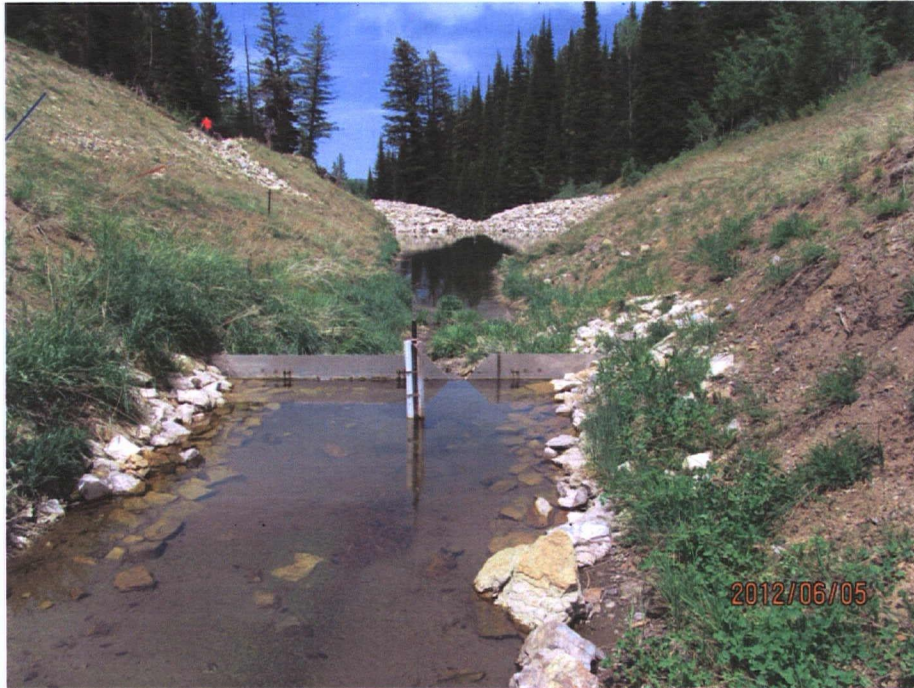
Photo taken looking north, showing the upper weir and the sediment control structure. No evidence of erosion is present.

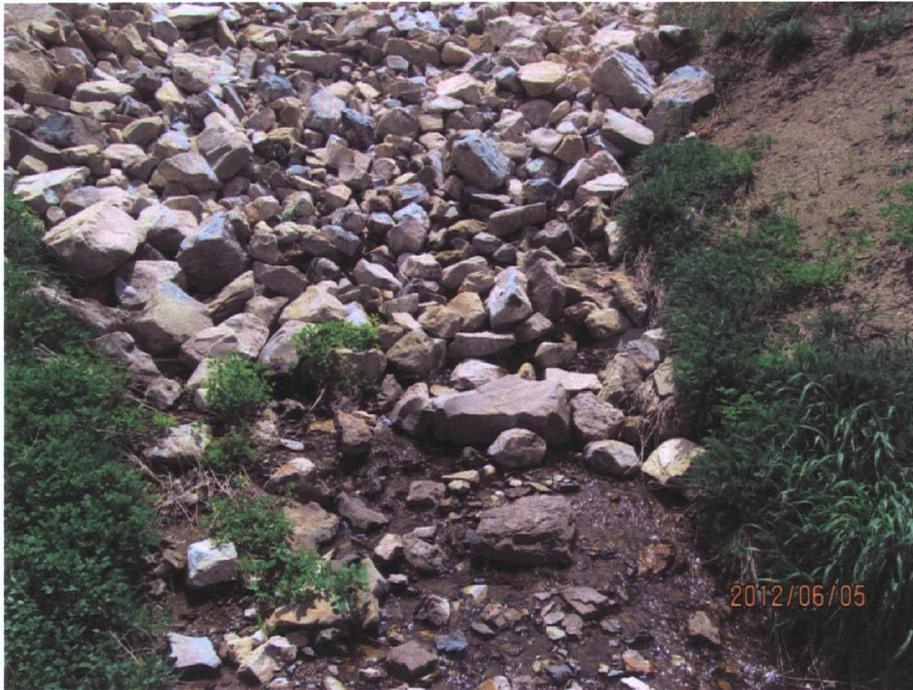
This photo is the toe of the riprap energy dissipater. Riprap armor is holding up well.

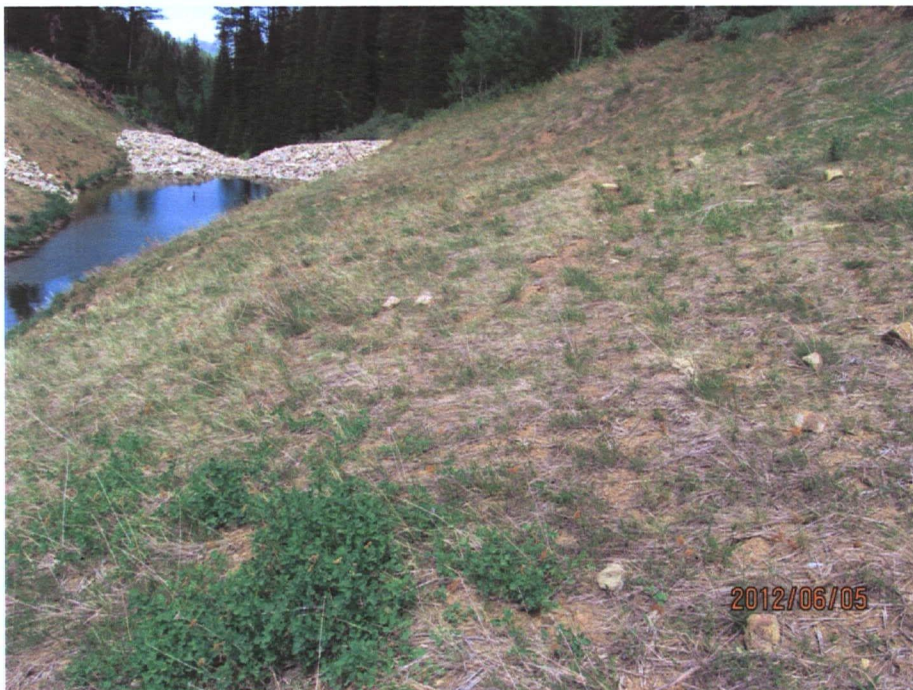
Photo taken looking north, showing the east slope of the sediment control pond. Vegetation has established well. No signs of erosion are observed on this slope.

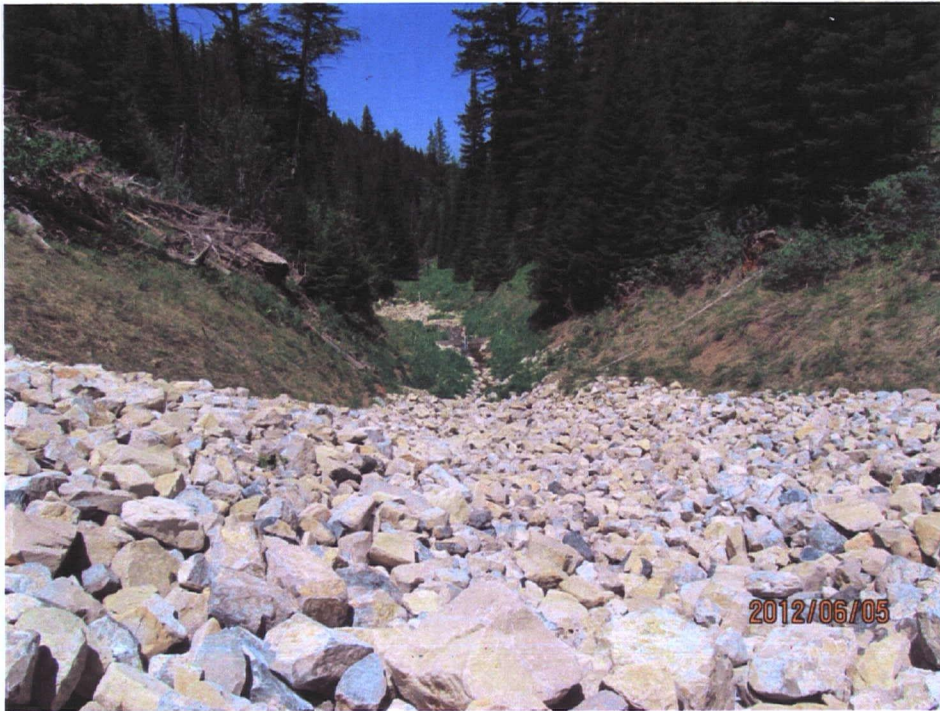
Photo taken looking north, from the top of the sediment control structure showing the lower weir and riprap lined channel below the sediment control structure.

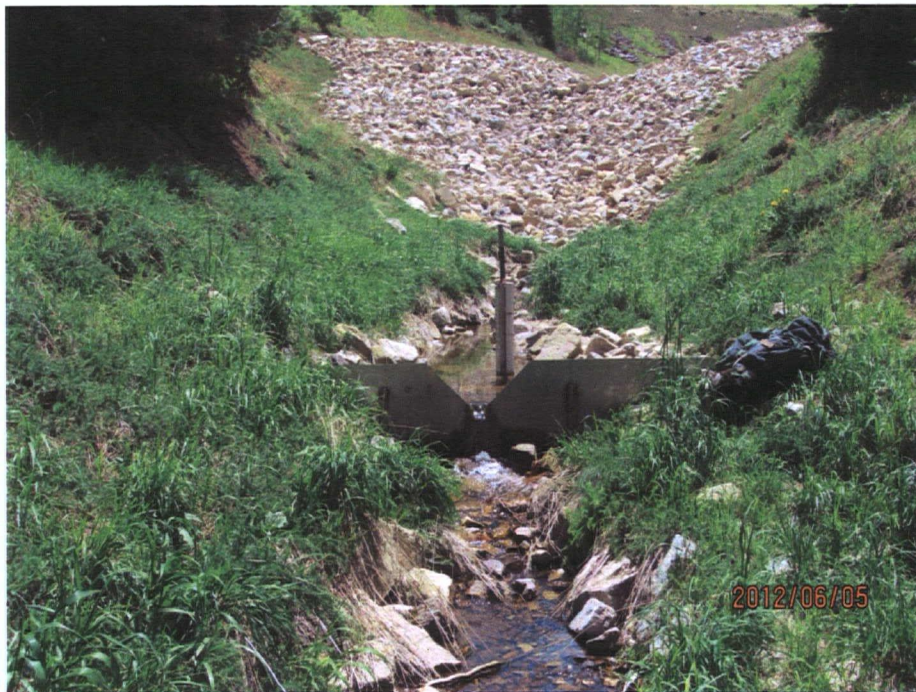
Photo taken looking south, showing a close up of the lower weir and riprap lined channel below the sediment control structure. This area is in good condition with vegetation well established on side-slopes.
